# Manhole Inspection Summary

Manhole # S19II\_031MH

**Location** Address: **1654 SAMLLWOOD ST** Cross Street: **PRESBURY ST**

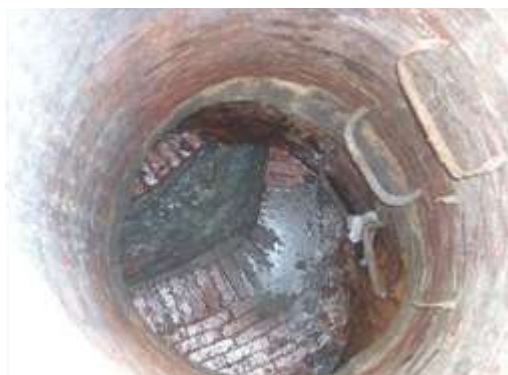
Top View

Comments **DUE TO CONSTRUCTION OF MANHOLE AND MISSING STEPS, COULD NOT GET AN ACCURATE TOP VIEW AS REQUESTED. S SHAPED CHANNEL IS ELONGATED AND WILL NOT FIT IN FRAME OF PHOTO. REWORK COMPLETED AS BEST AS POSSIBLE. 3-12-09**

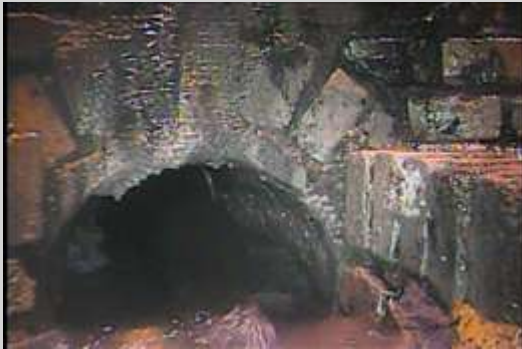
12 O'Clock Outflow

12 in. Circular Gravity Sewer  
Pipe Out @ 12 O'Clock

Pipe Height: **12** (in.) Rod and Bar (Angled)  
Pipe Material: **Clay** ☐ Pipe Lined  
Invert Depth: **12.64** (ft.) Flow Characteristics: **Fast**  
Deposits: ☒ None ☐ Mud ☐ Sludge ☐ Debris ☐ Grease  
Silt Depth: (in.) Deposits Extent:  
Infiltration: **None** Pipe Seal Cond: **Sound**

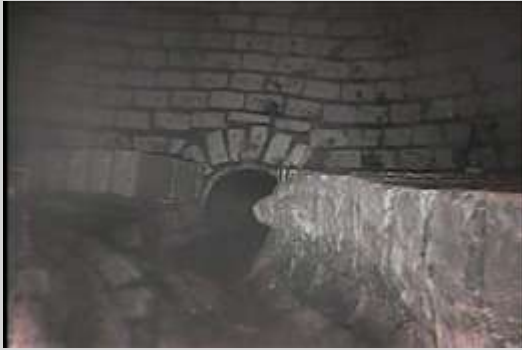
9 O'Clock Inflow

10 in. Circular Gravity Sewer  
Pipe In @ 9 O'Clock

Pipe Height: **12** (in.) Rod and Bar (Angled)

Infiltration: **None** Pipe Seal Cond: **Sound**
